# Environmental Projects: Volume 4

## Asbestos Survey

Goldstone Deep Space Communications Complex

Jet Propulsion Laboratory  
California Institute of Technology  
Pasadena, California

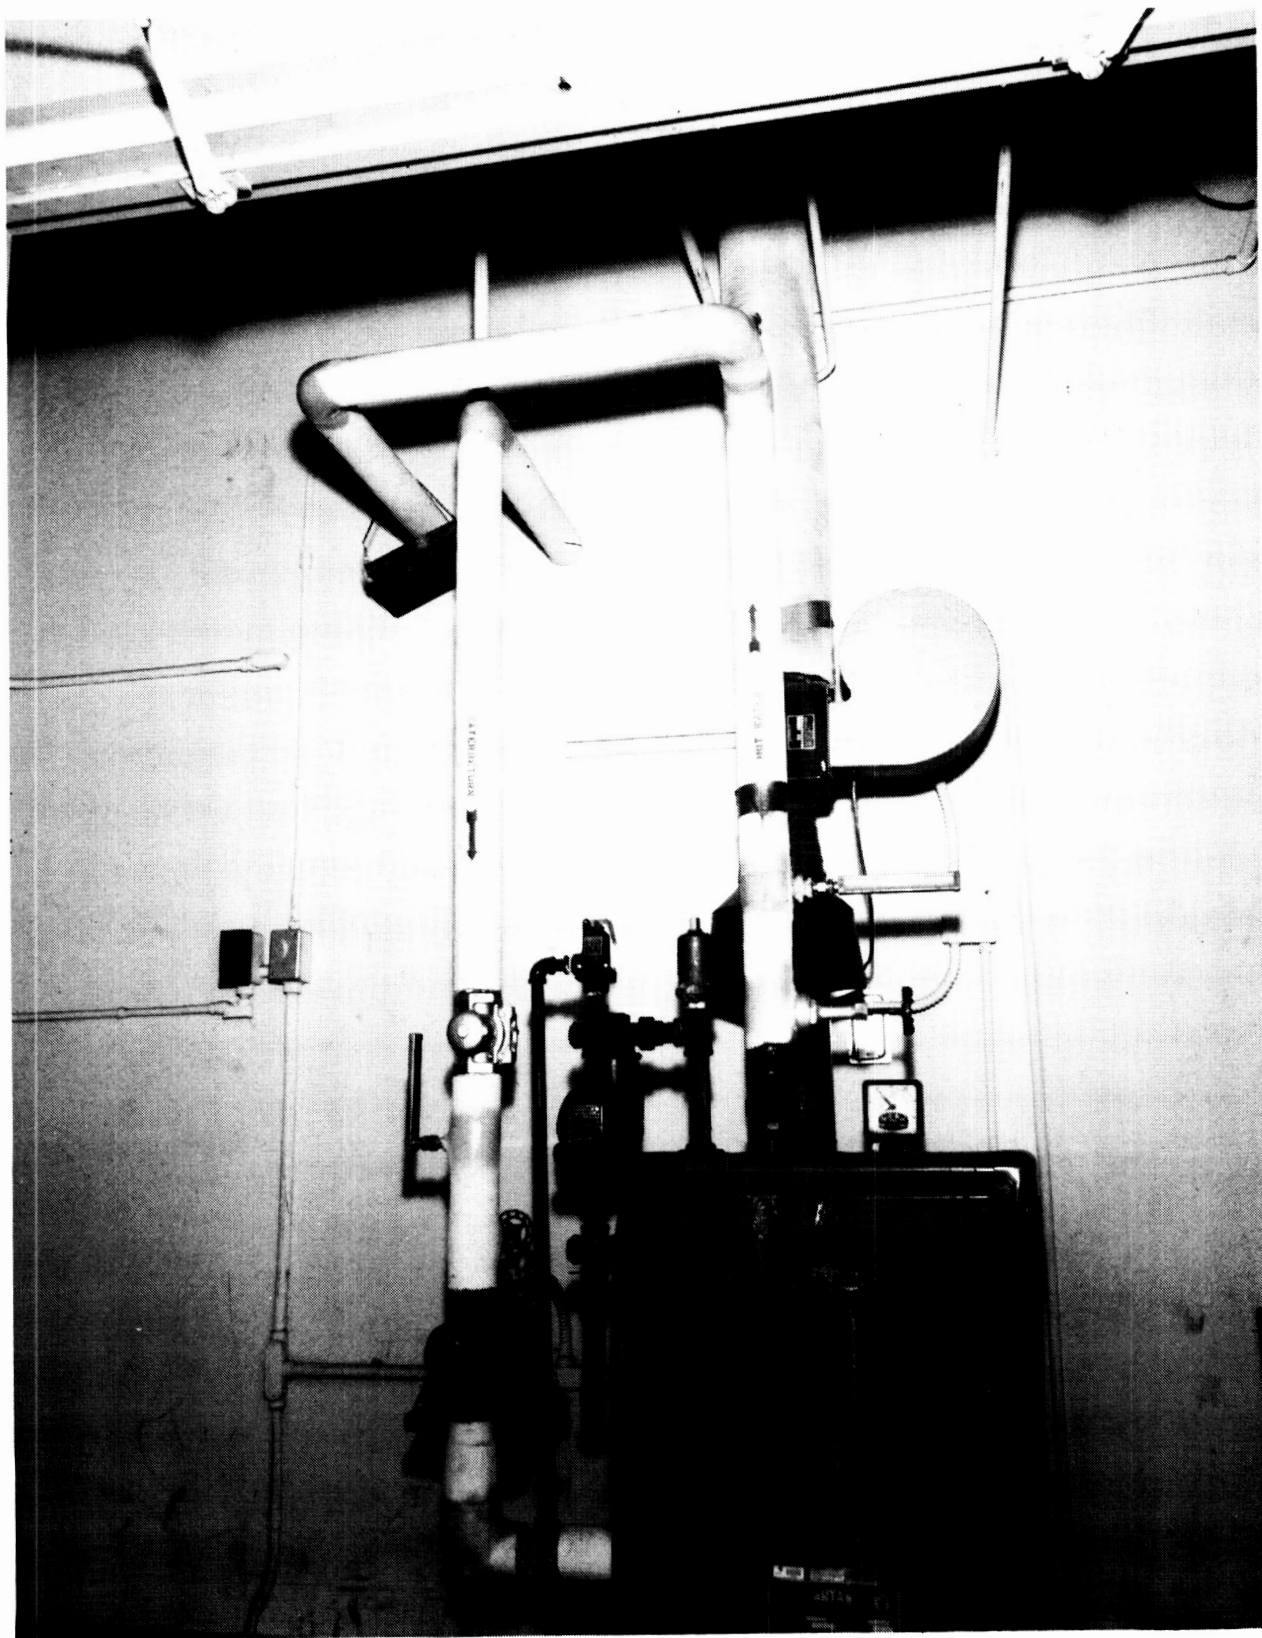
Figure 28. Echo Site: Building G-33, Boiler Room 133, Asbestos-Containing Pipe Lagging.

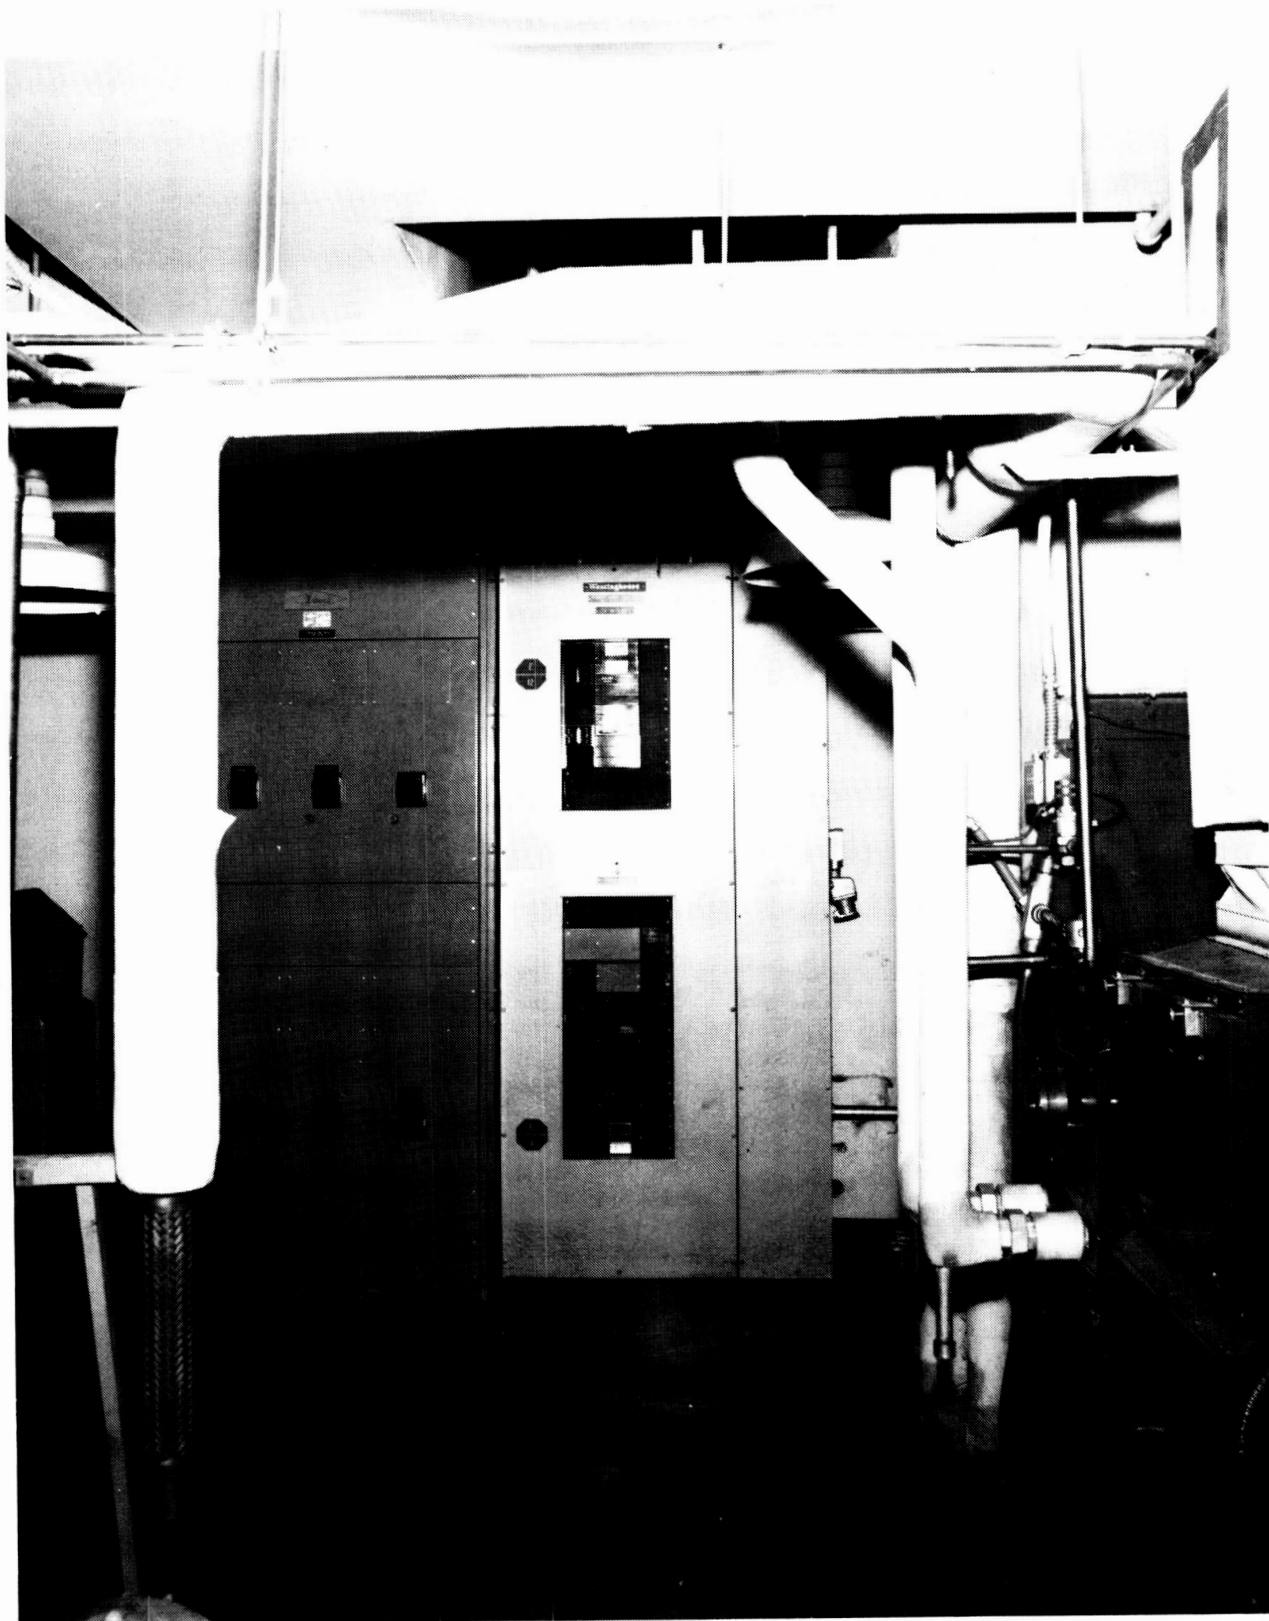
Figure 29. Echo Site: Building G-33, Mechanical Equipment Room 134, Asbestos-Containing Pipe Lagging.

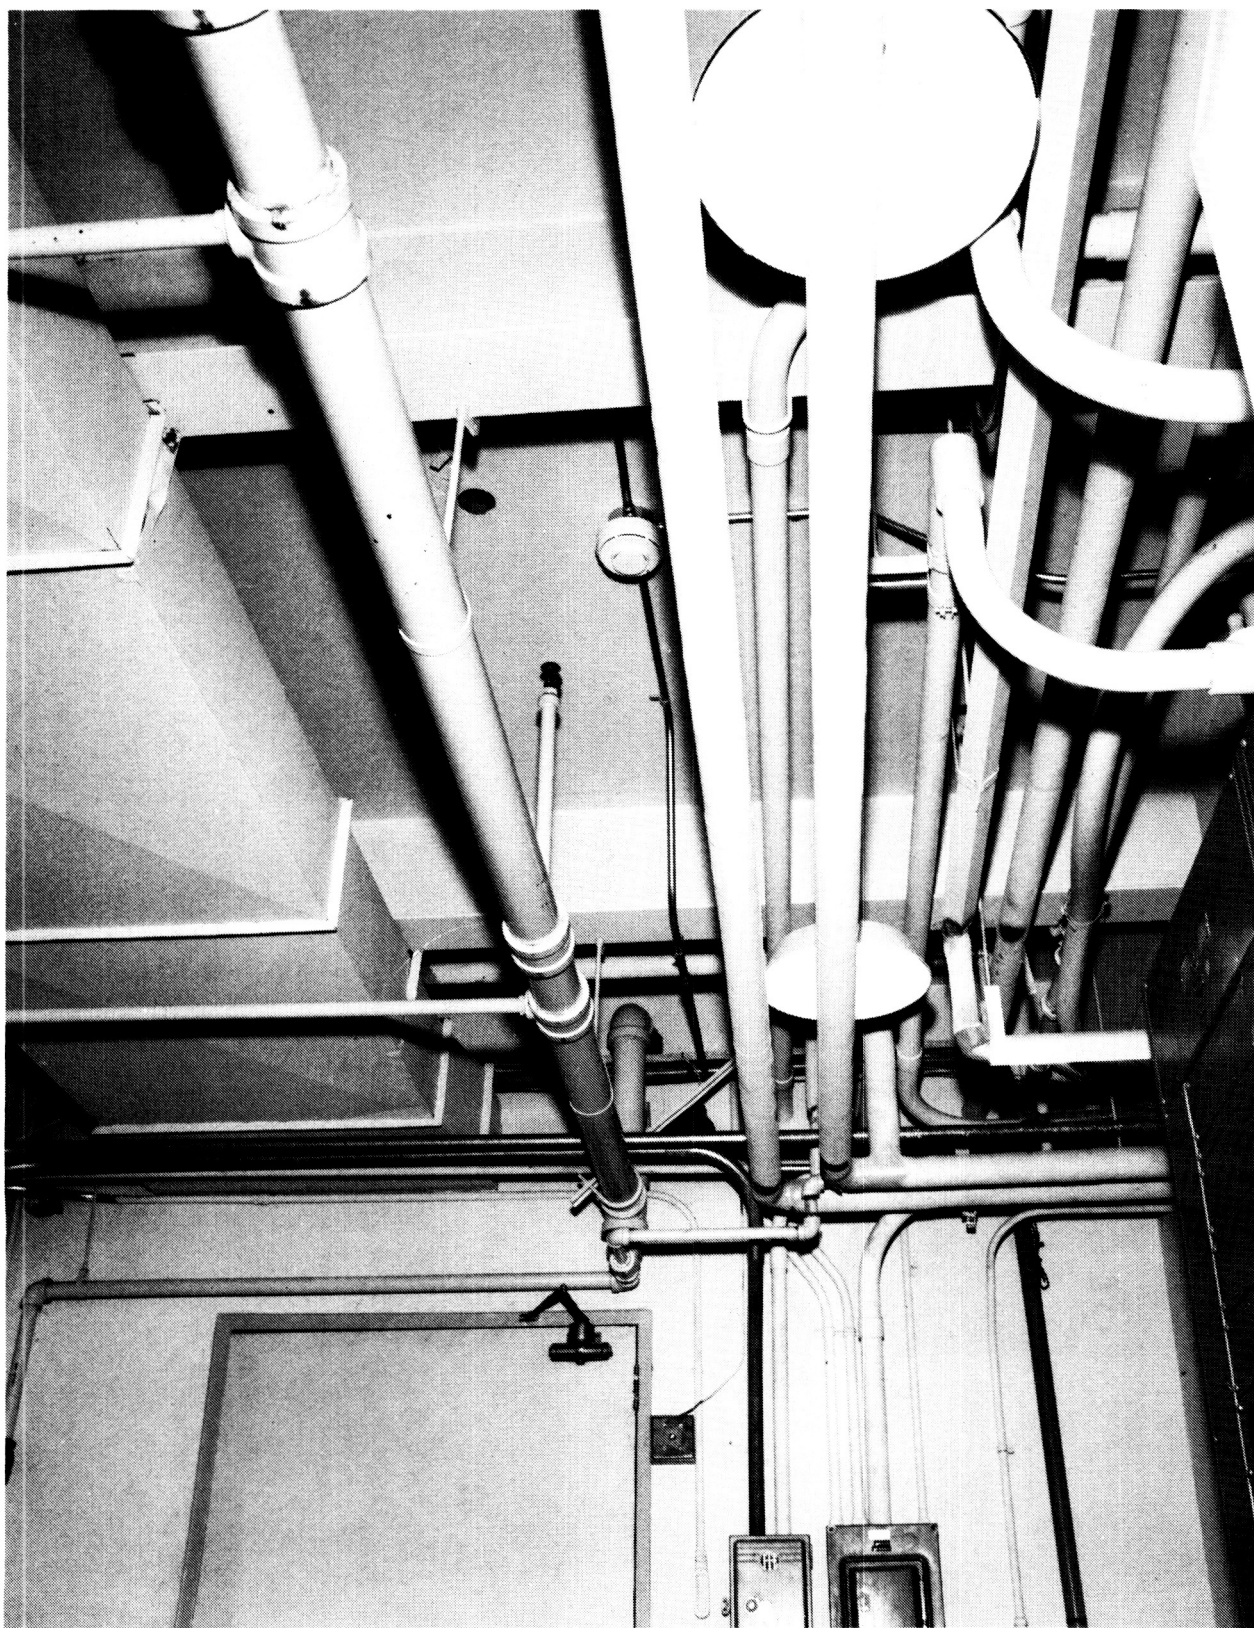
Figure 30. Echo Site: Building G-33, Electrical Room 138, Asbestos-Containing Pipe Lagging.

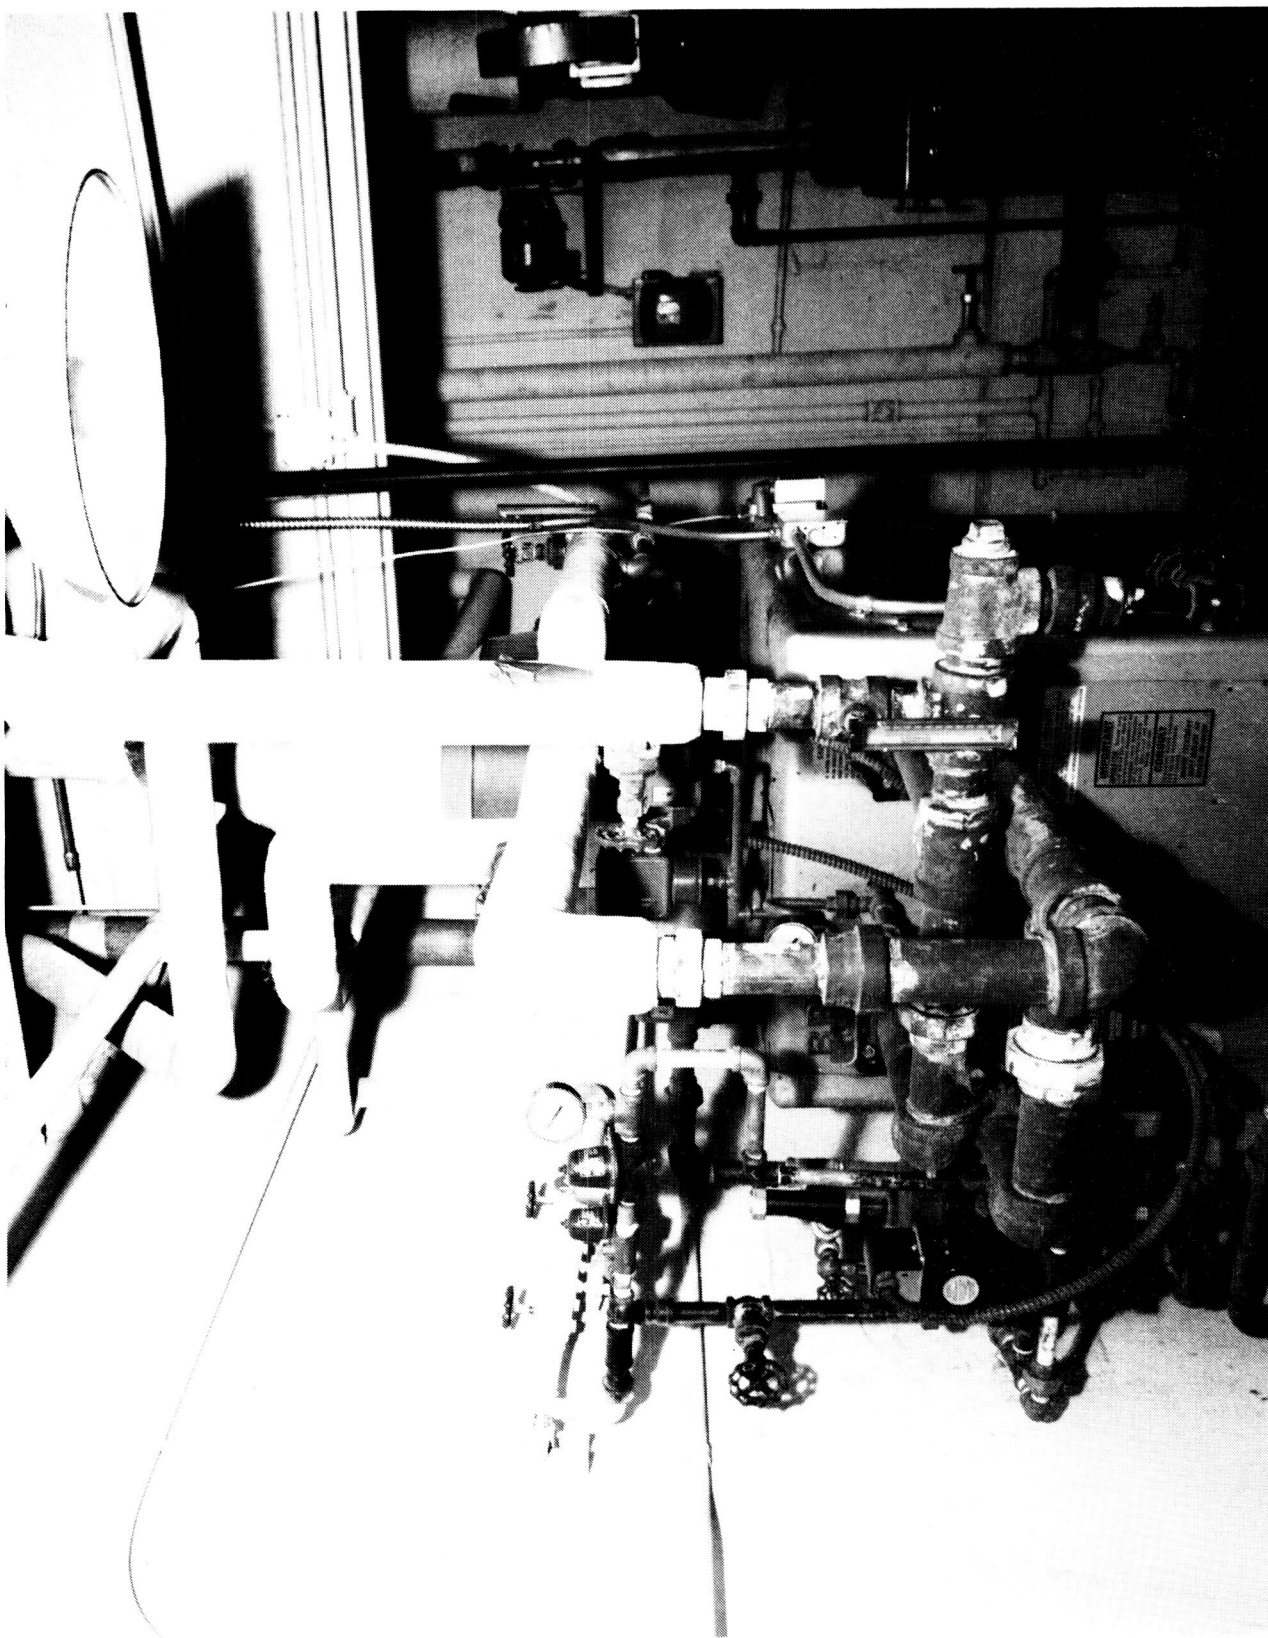
Figure 31. Echo Site: Building G-33, Boiler Room 140, Asbestos-Containing Pipe Lagging.

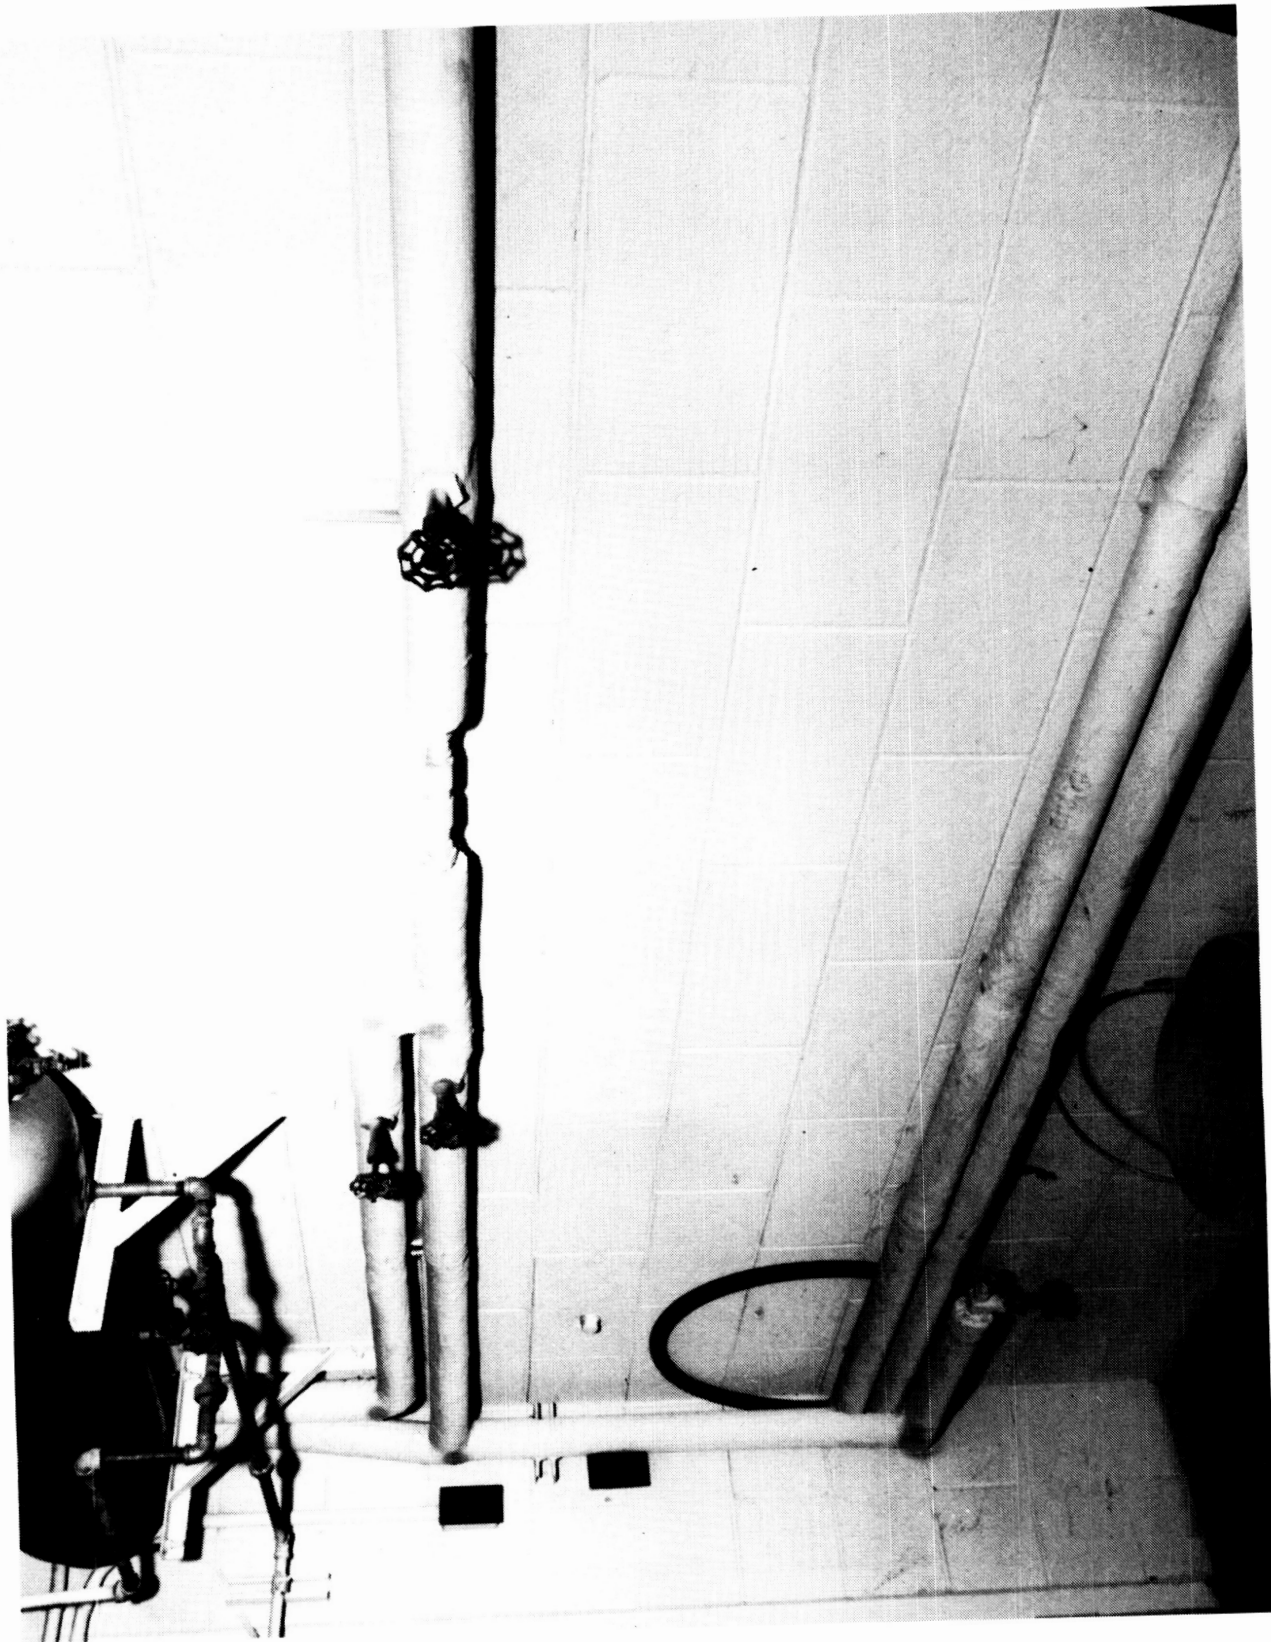
Figure 32. Echo Site: Building G-33, Boiler Room 140, Asbestos-Containing Pipe Lagging.

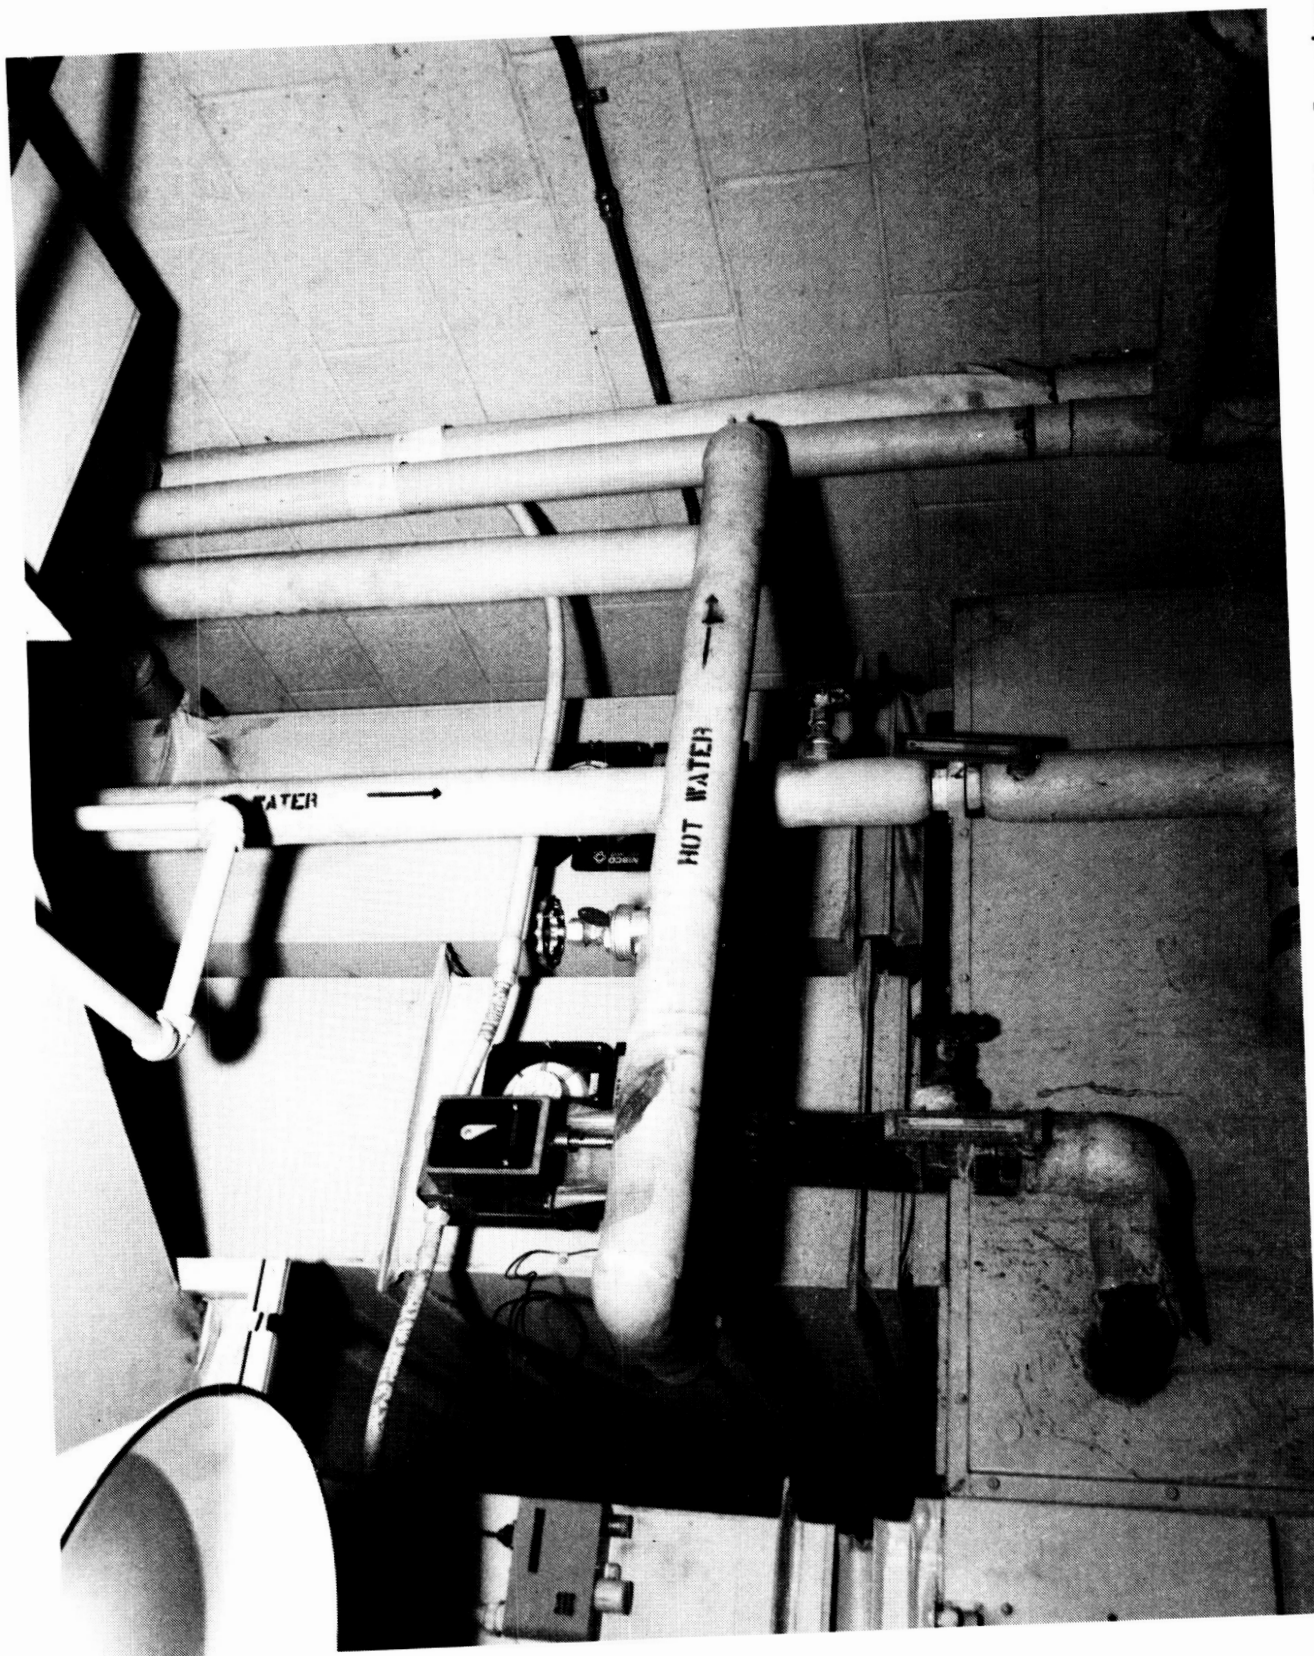
Figure 33. Echo Site: Building G-33, Mechanical Equipment Room 141, Asbestos-Containing Pipe Lagging.

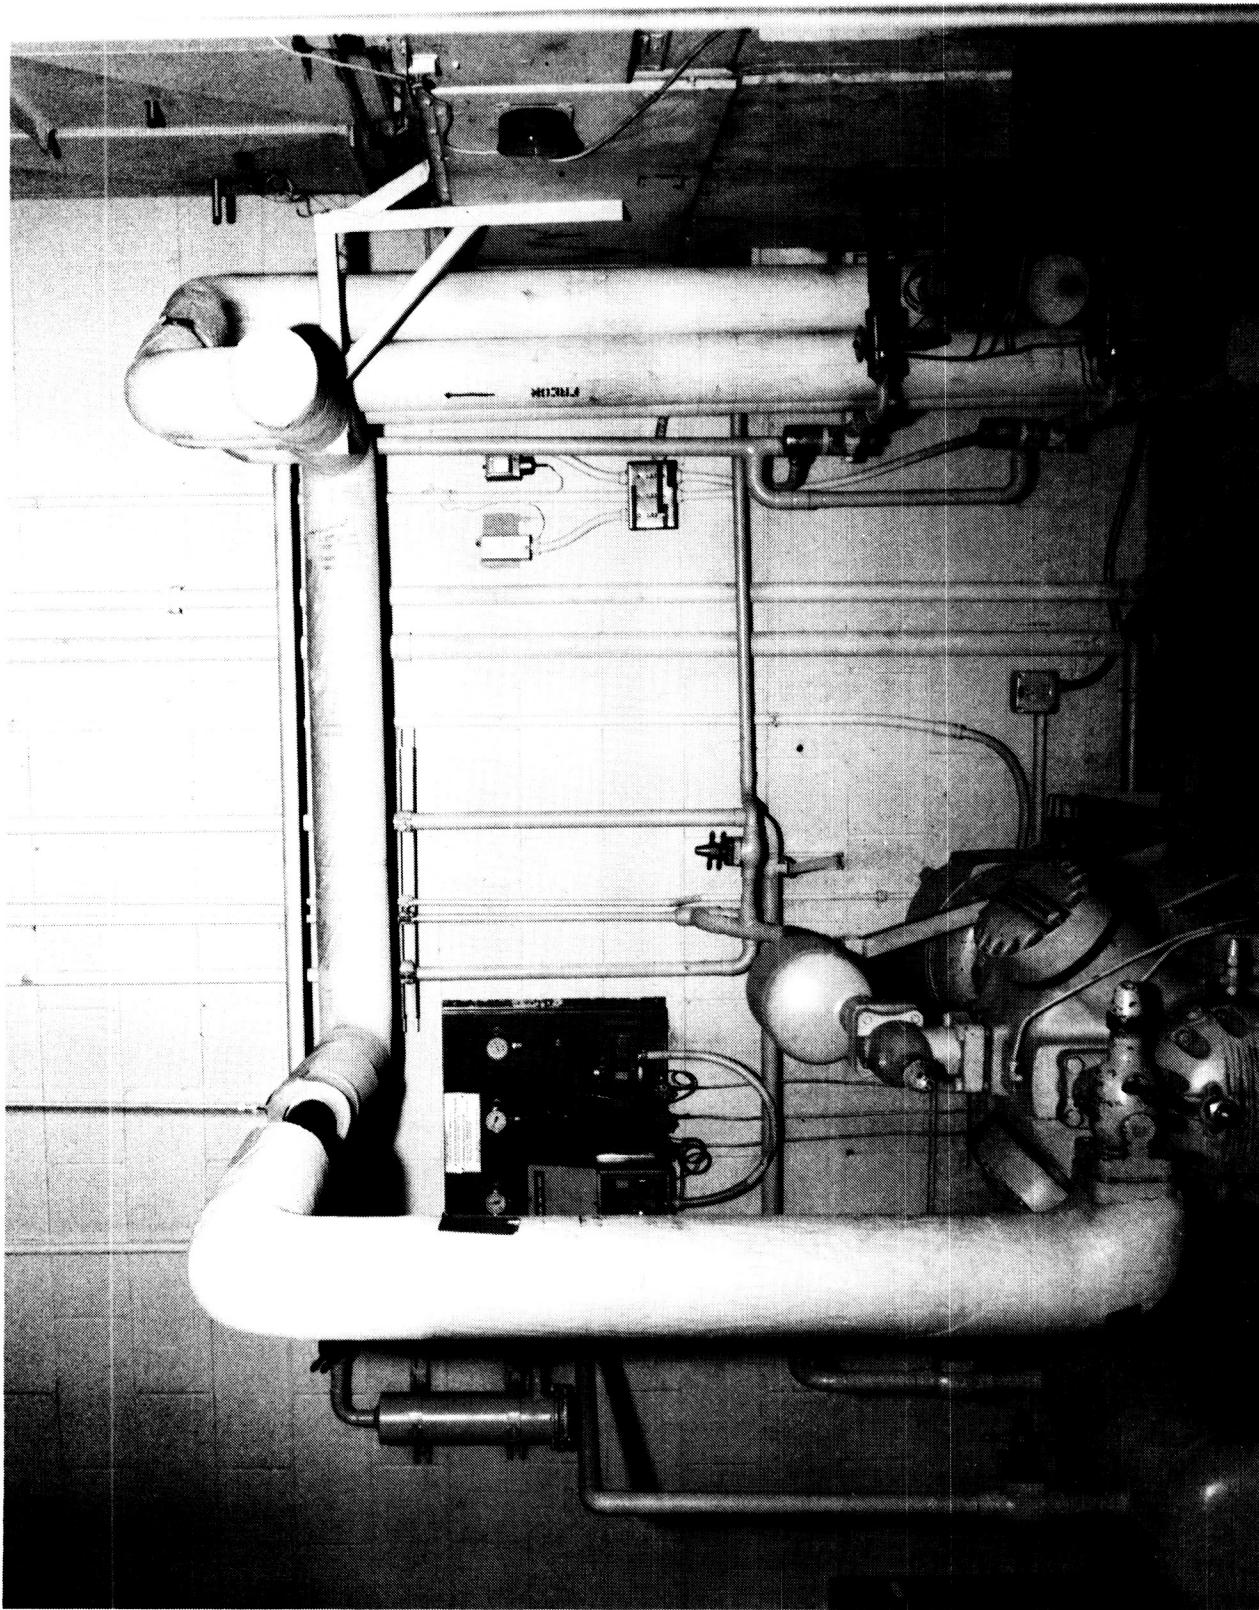
Figure 34. Echo Site: Building G-33, Mechanical Equipment Room 141, Asbestos-Containing Pipe Lagging.

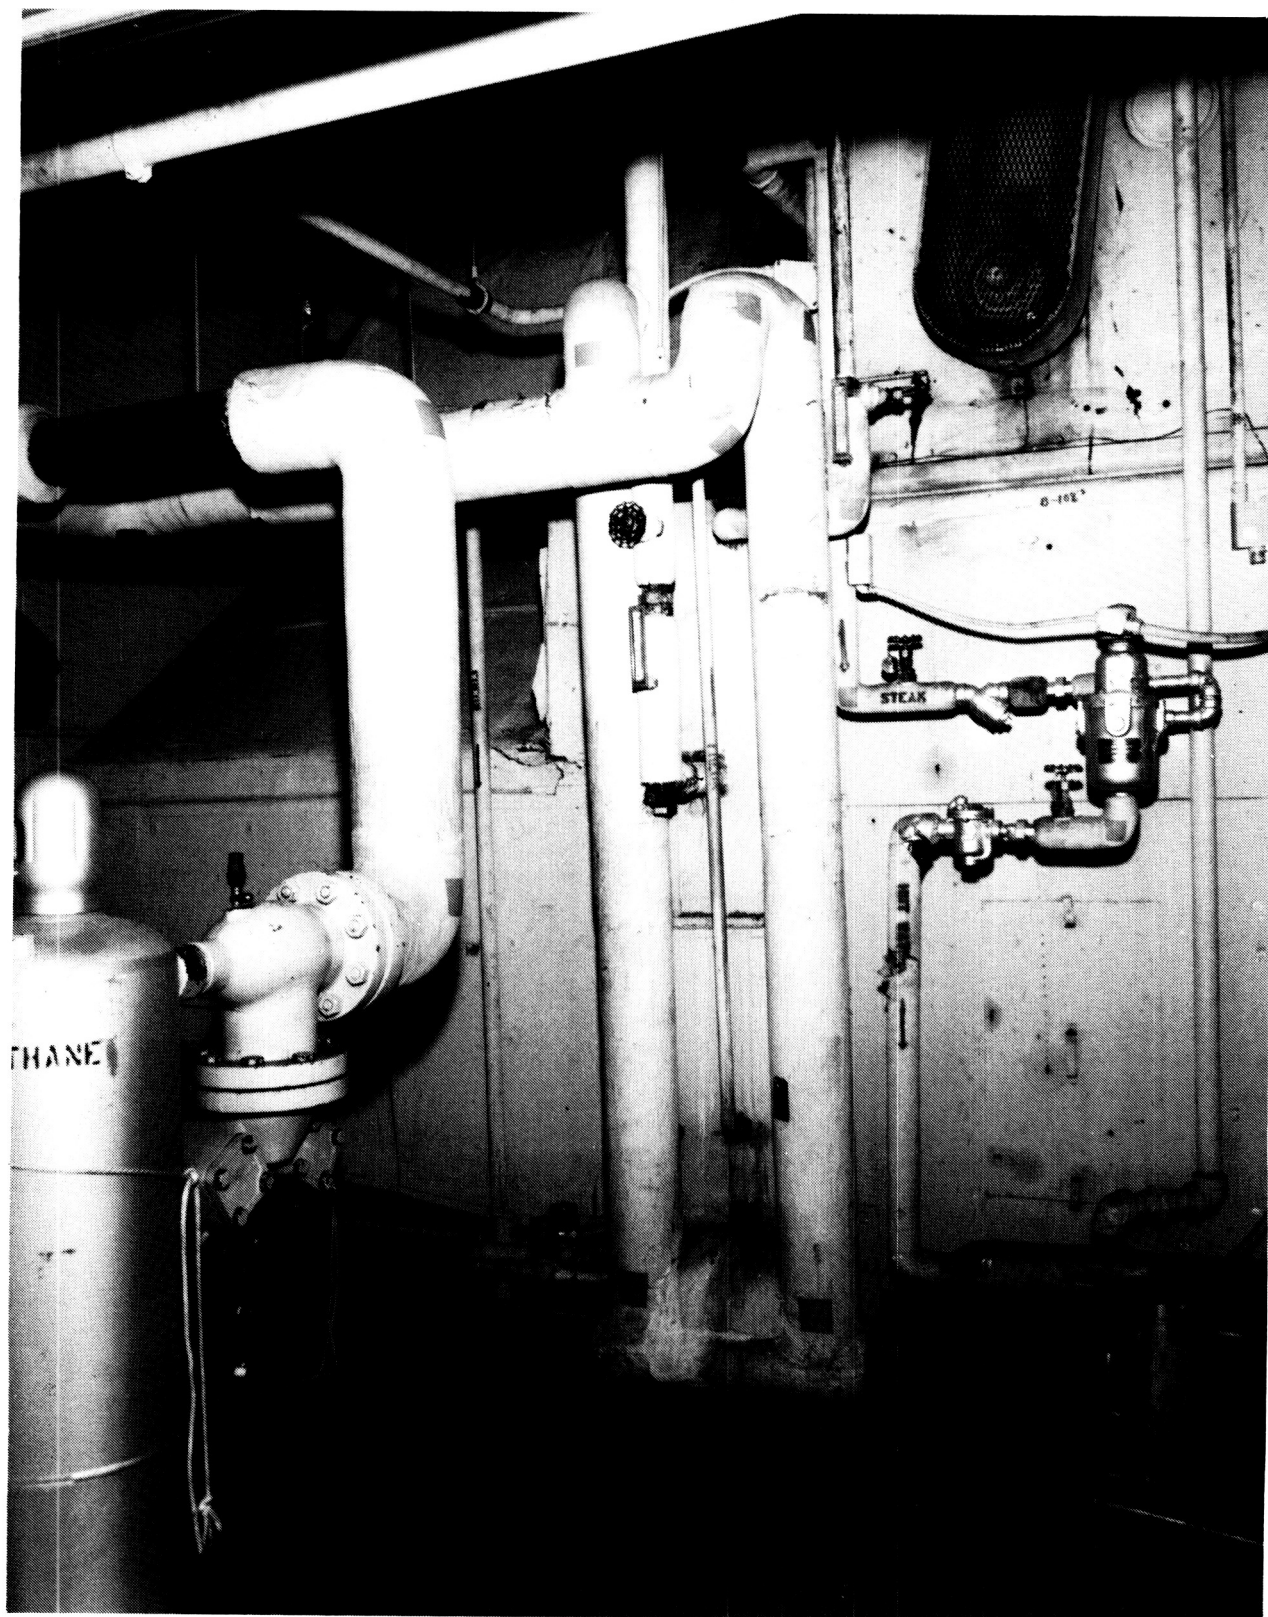
Figure 39. Echo Site: Building G-38, Mechanical Equipment Room 115, Asbestos-Containing Pipe Lagging.

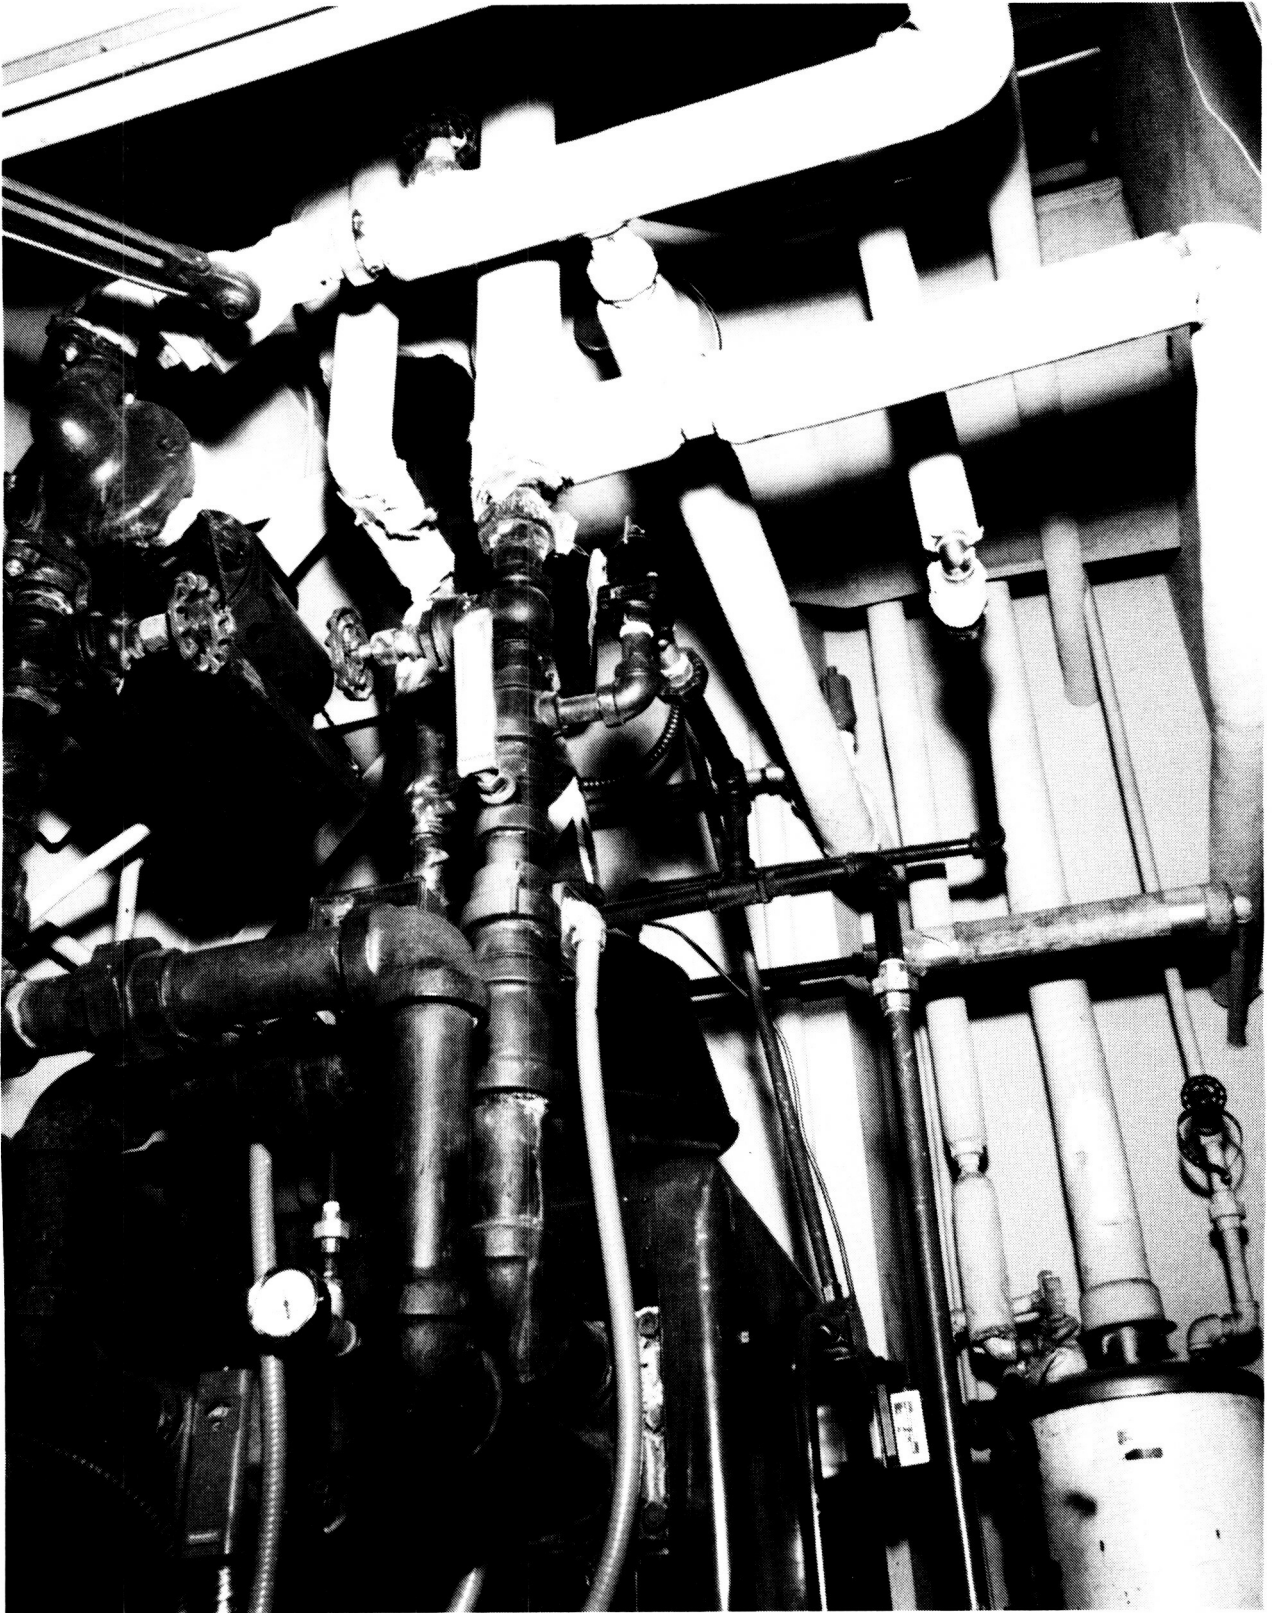
Figure 40. Echo Site: Building G-38, Boiler Room 129, Asbestos-Containing Pipe Lagging and Boiler Insulation.

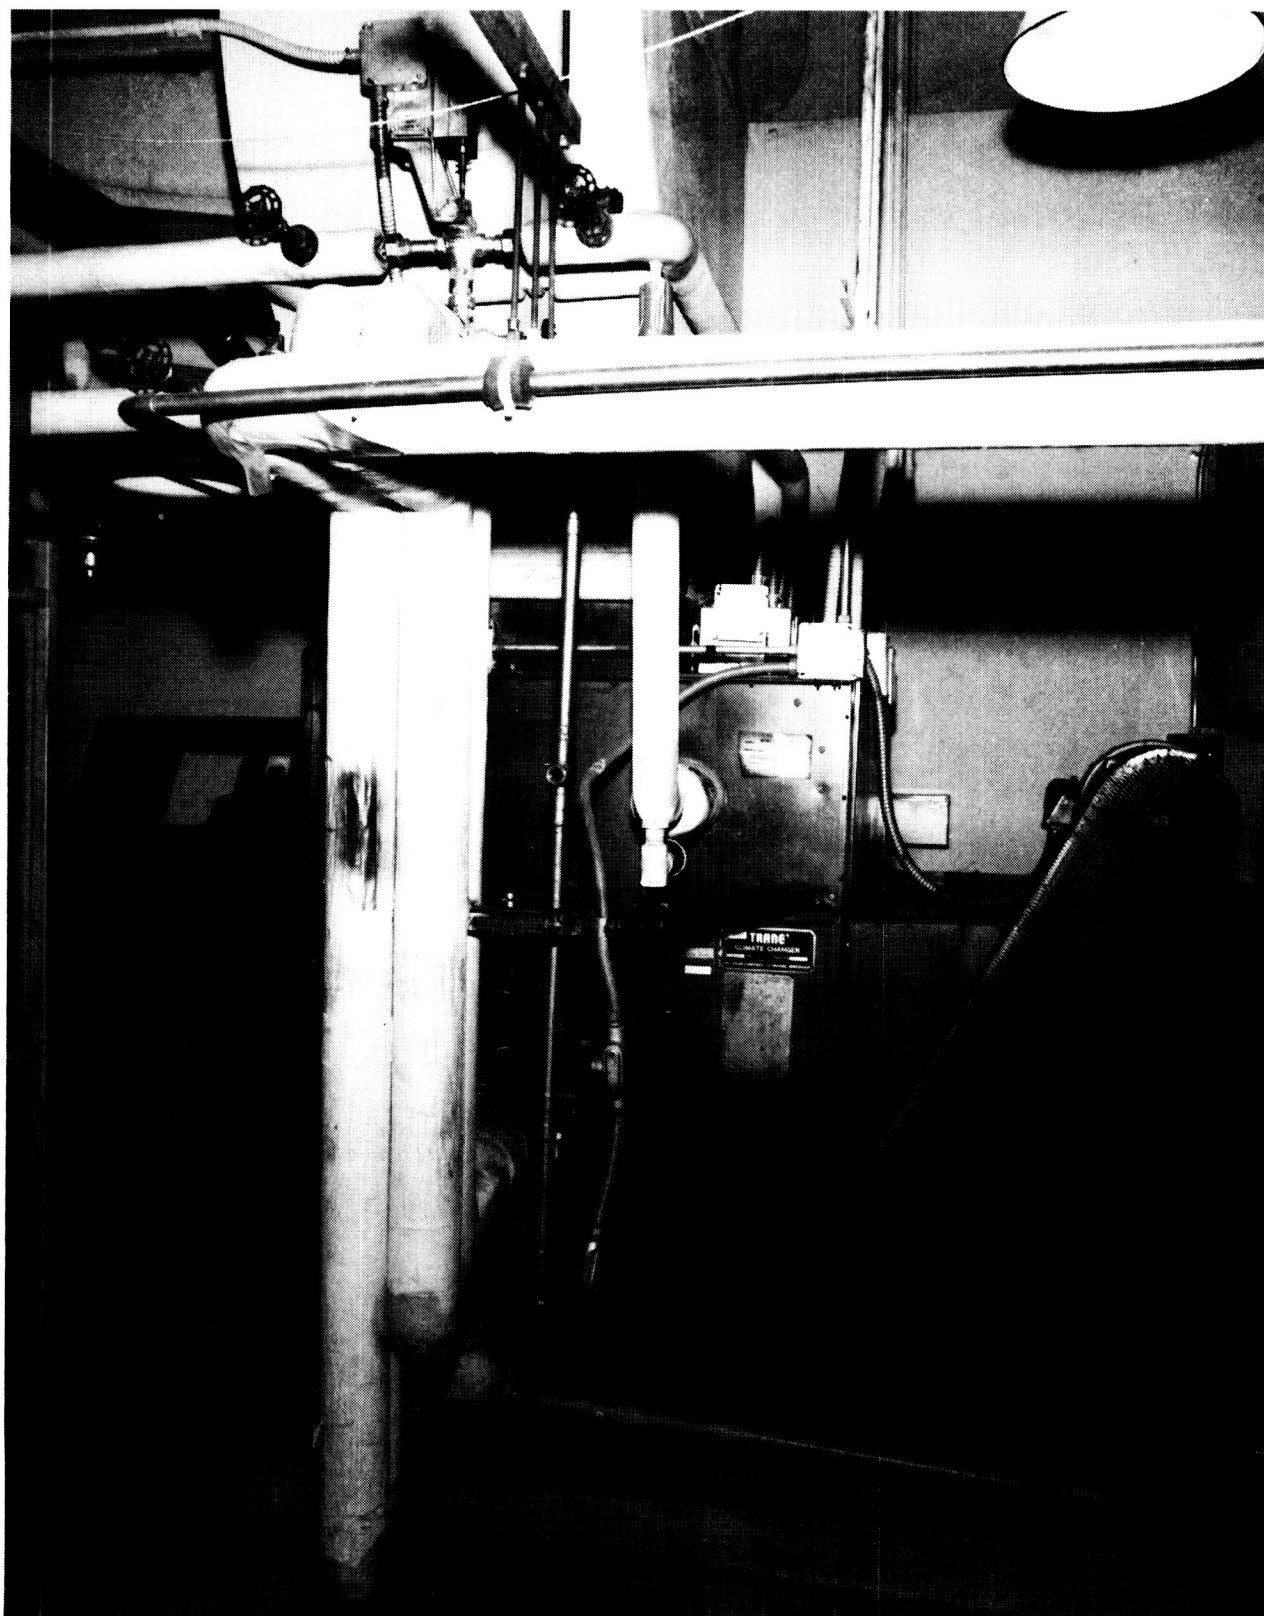
Figure 41. Echo Site: Building G-38, Mechanical Equipment Room 131, Asbestos-Containing Pipe Lagging.

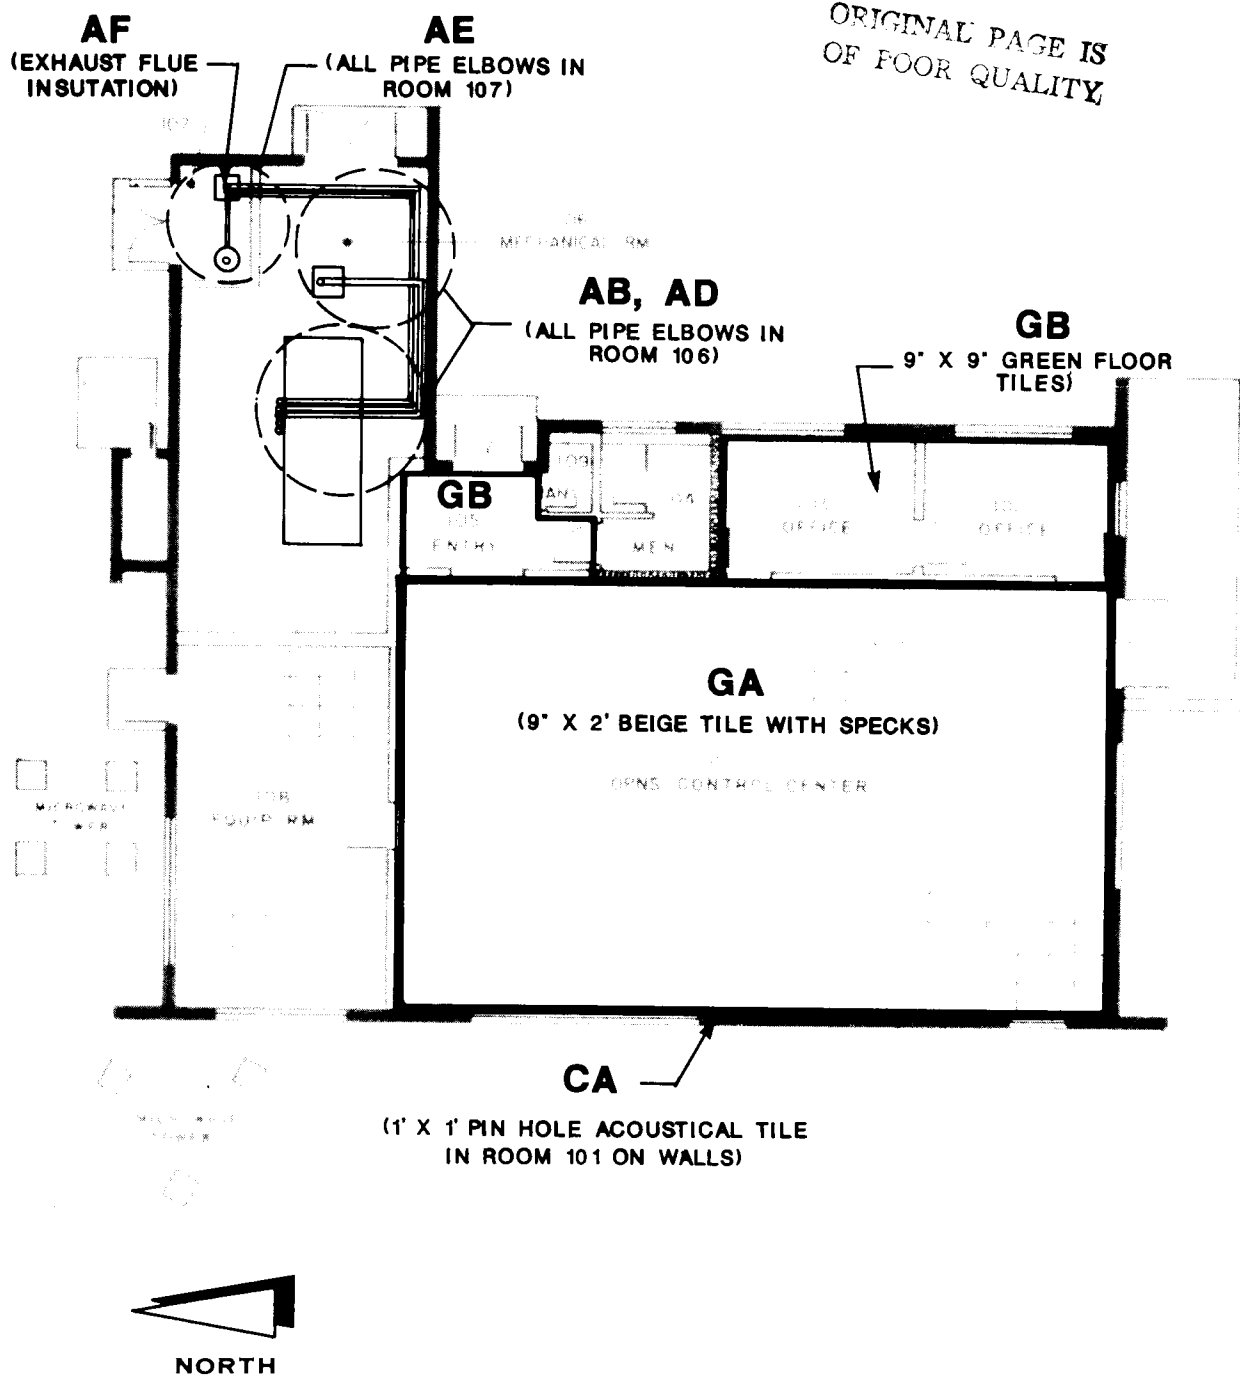
Figure 48. Venus Site: Control Building G-51.

Comments: 9 in. X 2 ft. BEIGE TILE WITH SPECKS. ROOMS 102, 103, AND 105 CONTAIN 9 X 9 in. GREEN TILE WITH WHITE STREAKS LIKE FLOORING IN BUILDING G-56. SEE FIGURE 48
